Space Shuttle Program

SSME Flight Readiness Review

June 28, 2001

SSME BLOCK II

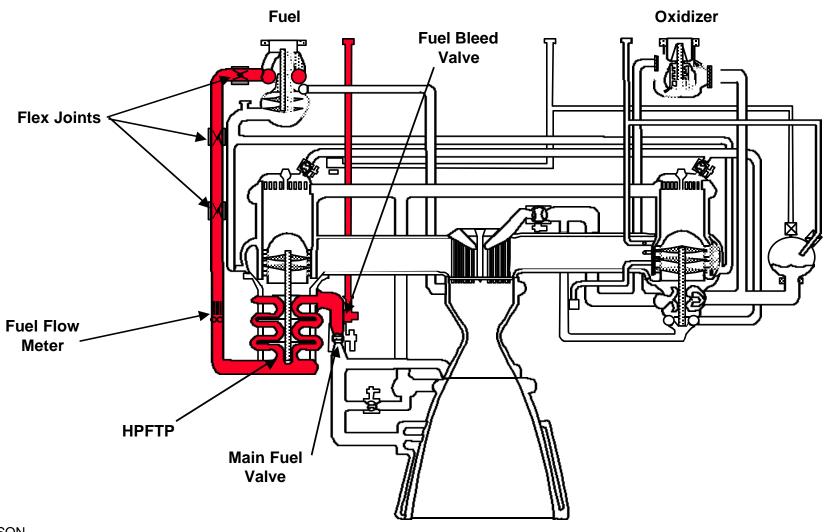
SSME Simplified Schematic

- Contamination observed in turbine and pump inlet and discharge of HPFTP 8018 post 902-794 (ruptures occurred during next test)
 - Identified as Viton (O-ring material: 3/8" x 3/16" x 1/8" max size)
 - O-ring mold surfaces identified (0.210" cross-section dia.)
- Subsequent disassembly of E0525 Main Fuel Valve also revealed Viton particles
 - Dust and particles entrapped within deadheaded cavities
- No Viton utilized in engine fuel system
- Viton O-Rings utilized in GSE (Canoga, SSC and Pratt & Whitney)
 - Various leak test and flushing fixtures and tooling
- Search for source ongoing
 - Cryogenic fracture surfaces verified
- Next test (902-796) conducted with no anomalies
 - Additional single tube rupture occurred during test 902-802
 - Likely from residual entrapped contamination

- No contamination found in STS-104 engines during flight processing
 - Minimal opportunity to introduce contamination
- All turbopumps are green run at SSC prior to flight
 - Potential contamination flushed during ground test
- Contamination related tube ruptures are Crit 3
 - 19 occurrences in over 2870 starts and 942,000 seconds of operation
